Monitoring Report No. 69

**Corbally
Co. Antrim**

AE/06/117

Site Name: Corbally Housing Development

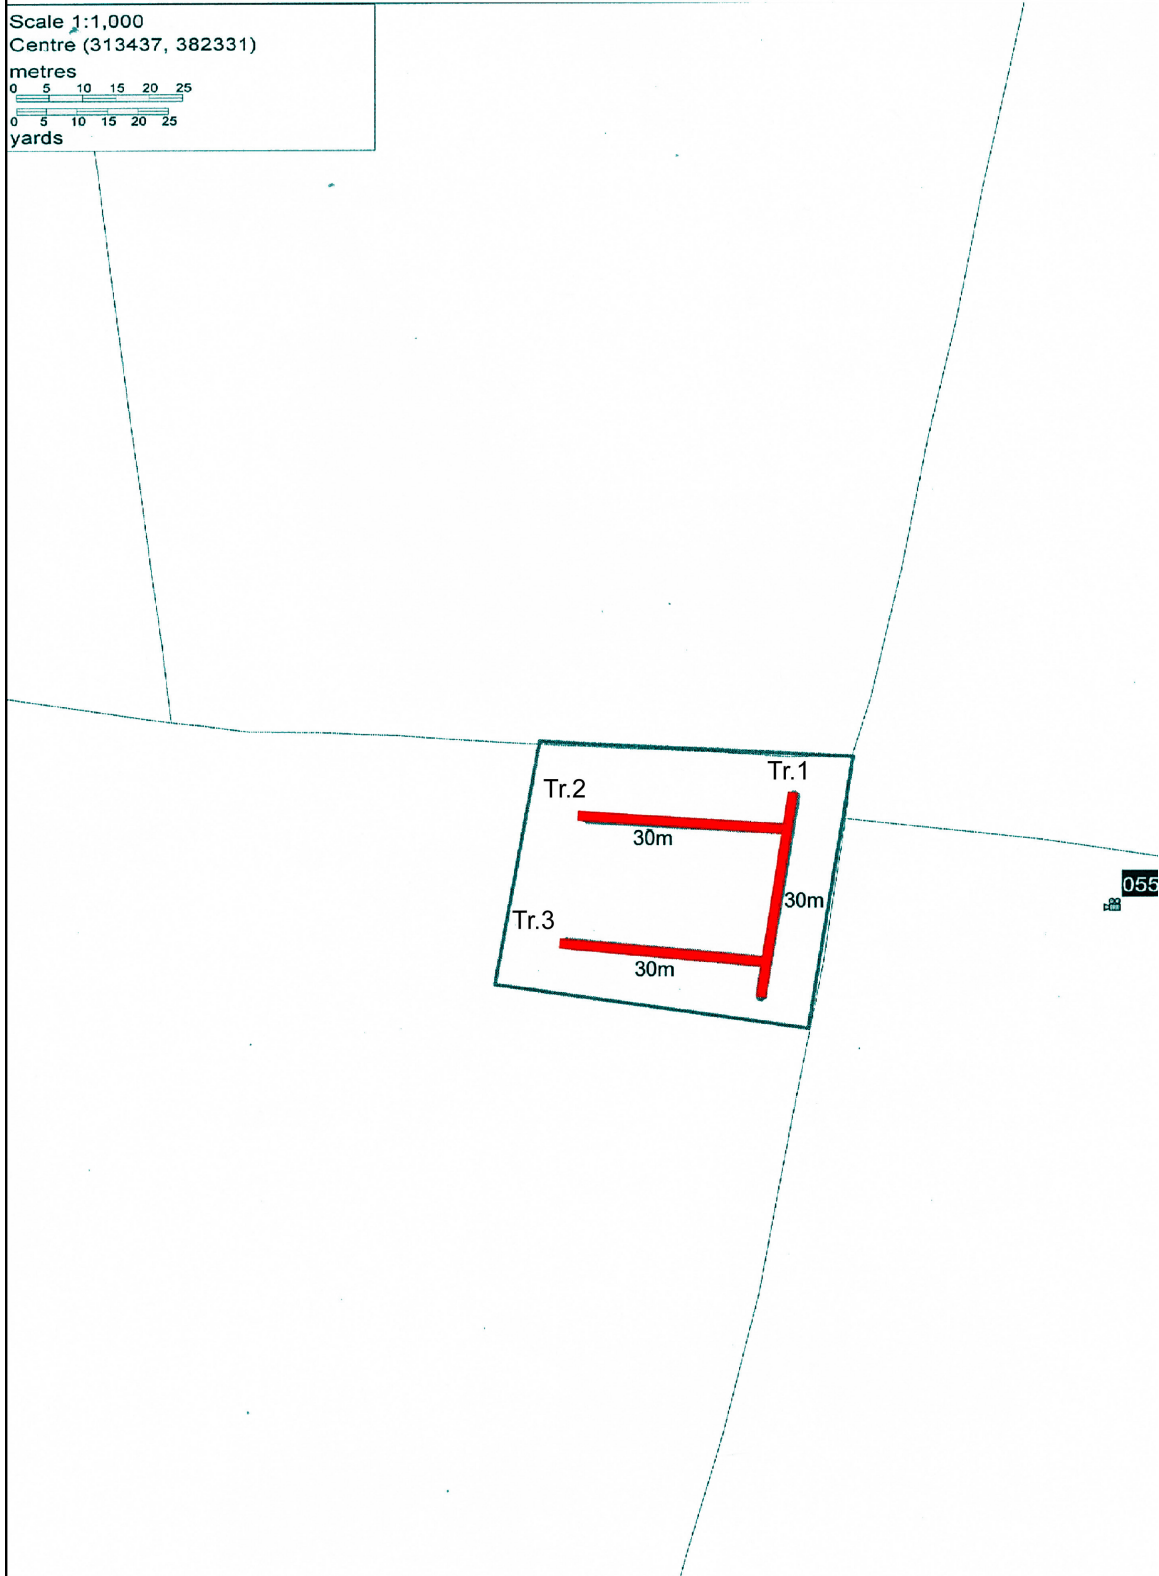
Figure 3: Plan of development site showing location of excavated evaluation trenches and recorded location of undated enclosure site (SMR ANT 055:140)

A total of three trenches were excavated as part of the evaluation procedure (Figure 3). The trenches were excavated using a mechanical digger equipped with a toothless “sheugh” bucket (Photo 1). Each trench measured 2m wide by 30m long.

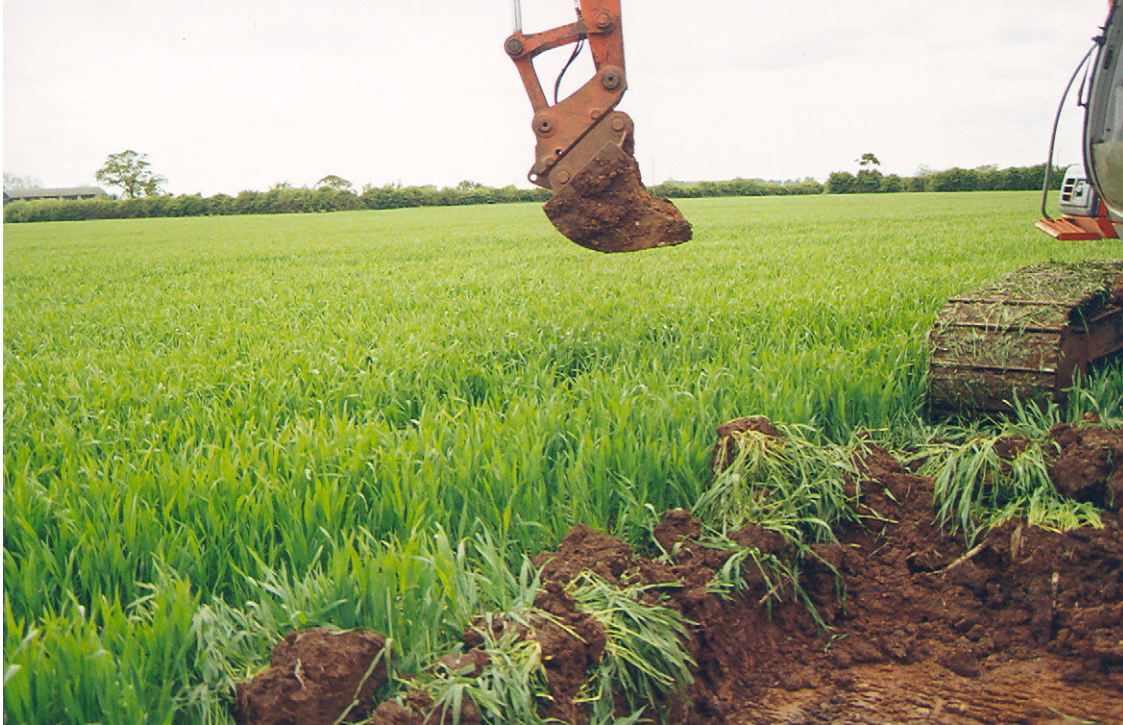
Photo 1: Excavation of Trench showing utilization of toothless “sheugh” bucket.

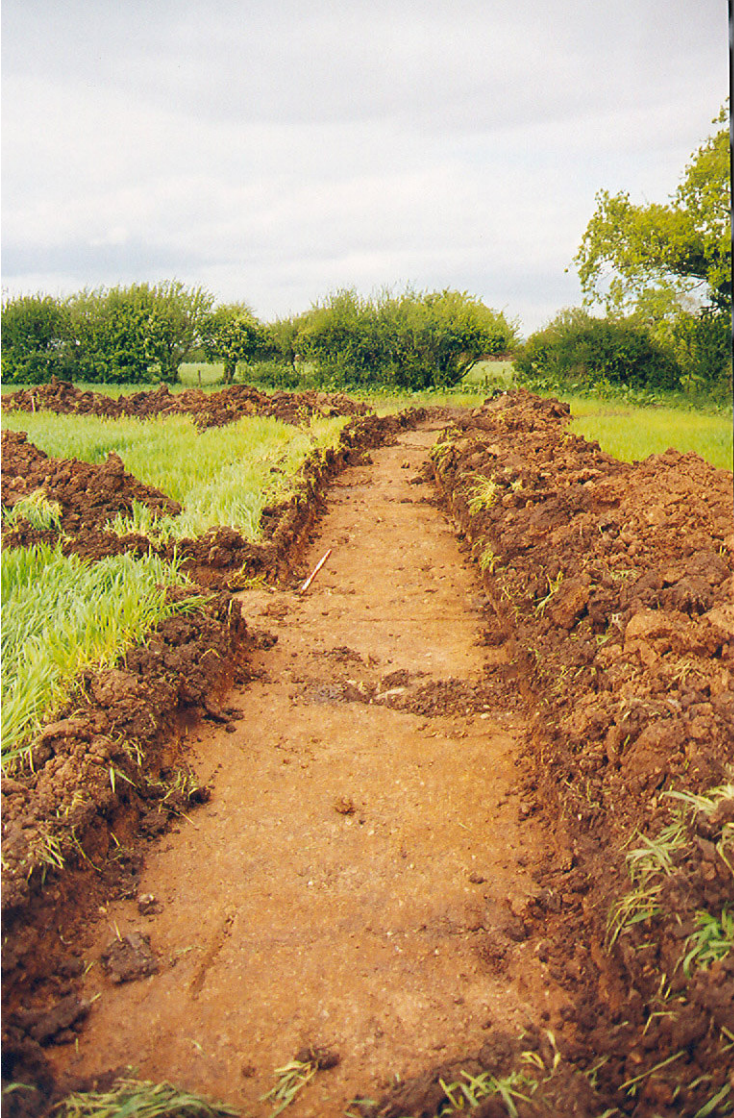
Trench 1: This trench was 2m wide by 30m long. It ran approximately north – south and was located approximately 5 m from the northern boundary and 5 m from the eastern boundary of the field. The topsoil was an orange - brown loam (Context 101), which was 30cm in depth. The topsoil sat directly on the subsoil (Context 102). The subsoil consisted of a light brown clay.. No archaeological artifacts or features were found during the excavation of this trench. Within the subsoil there were a number of areas of darker subsoil found. These were investigated and no evidence of an archaeological origin was uncovered. It seems likely they were the result of root action (Photo 2).

Photo 2: Trench 1 looking northwards after excavation showing surface of subsoil (Context 102).

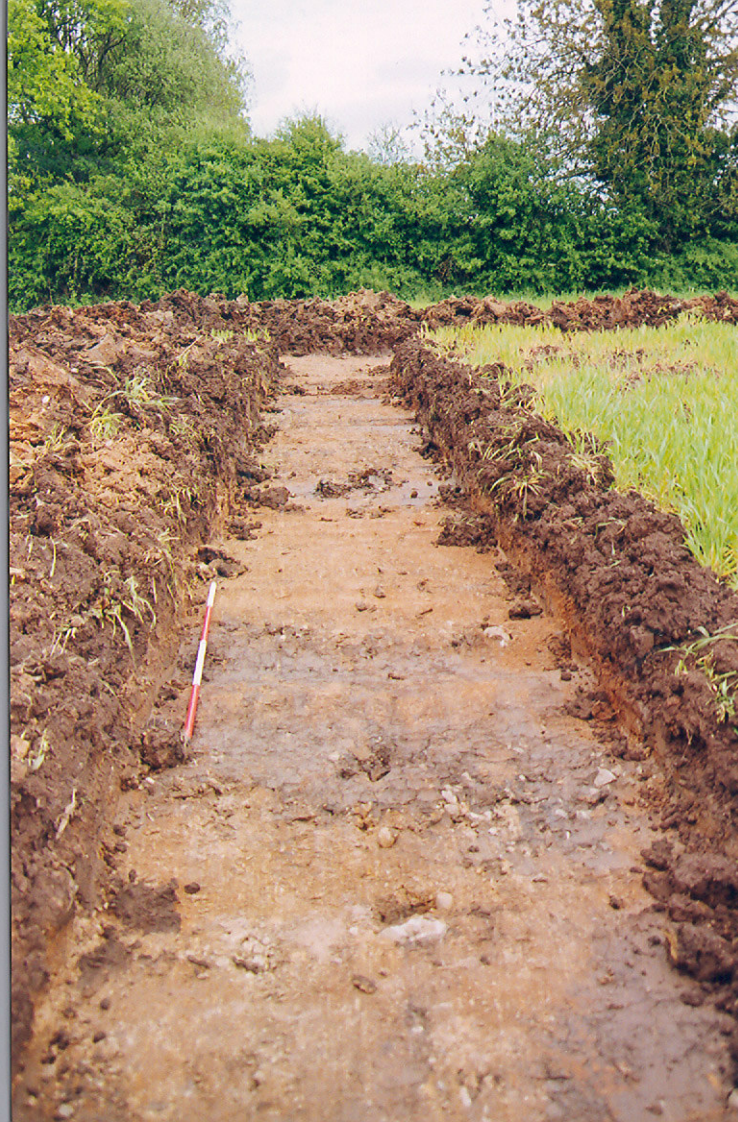
Trench 2: This trench was 2m wide by 30m long. It ran approximately east – west, emerging at a right angle from and approximately 5m south of the north end of Trench 1. The topsoil in this trench was an orange - brown loam (Context 201), which was 30cm in depth. The topsoil sat directly over the light brown clay subsoil (Context 202). A two parallel dark bands and an irregular area of slightly darker subsoil were uncovered in this trench. They were investigated but appear to have been the result of deep ploughing. No archaeological artifacts or features were found during the excavation of this trench (Photo 3).

Photo 3: Trench 2 looking eastwards after excavation showing surface of subsoil (Context 202).

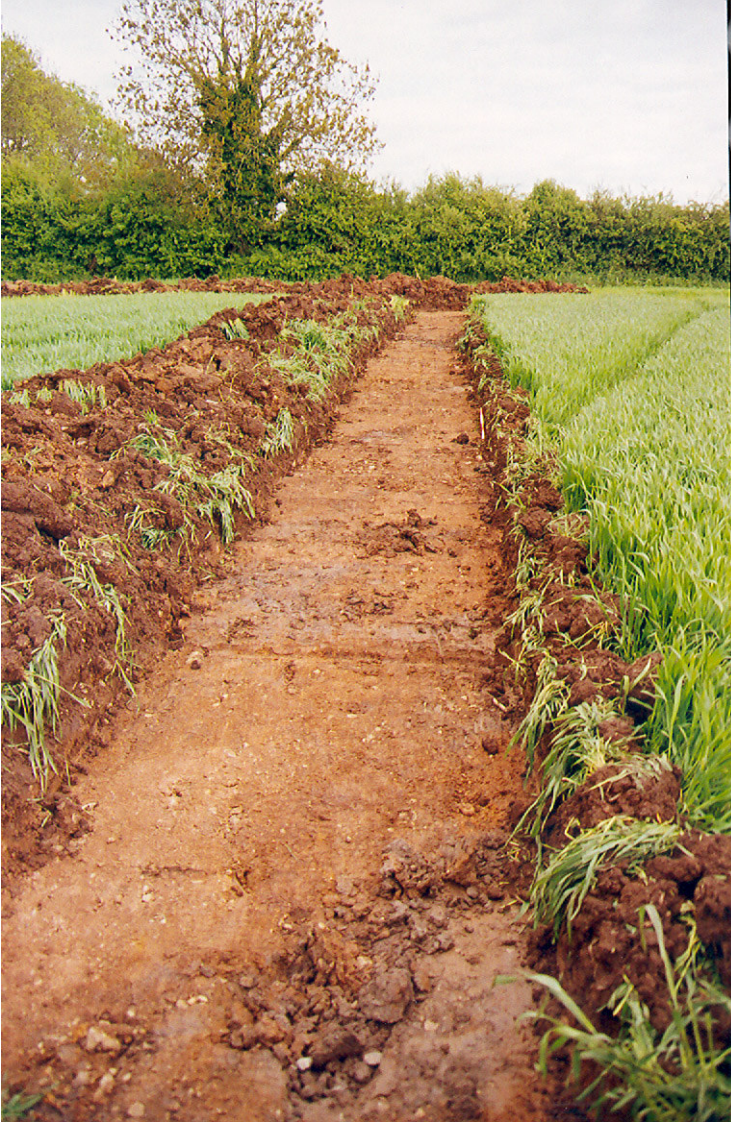
Trench 3: This trench was 2m wide by 30m long. It ran approximately east – west, emerging at a right angle from and approximately 5m north of the south end of Trench 1. The topsoil in this trench was an orange - brown loam (Context 301), which was 30cm in depth. The topsoil sat directly over the light brown-yellow clay subsoil (Context 302). As in Trench 2 there was some suggestion of dark bands within the subsoil, these also were investigated and appear to have been the result of ploughing. No archaeological artifacts or features were found during the excavation of this trench (Photo 4).

Photo 4: Trench 3 looking eastwards after excavation showing surface of subsoil (Context 302).
