Monitoring Report No. 180

**Monitoring of engineering pits
Market Yard
Coleraine
Co. Derry**

Site Name: Market Yard, Coleraine, Coleraine, Co. Derry

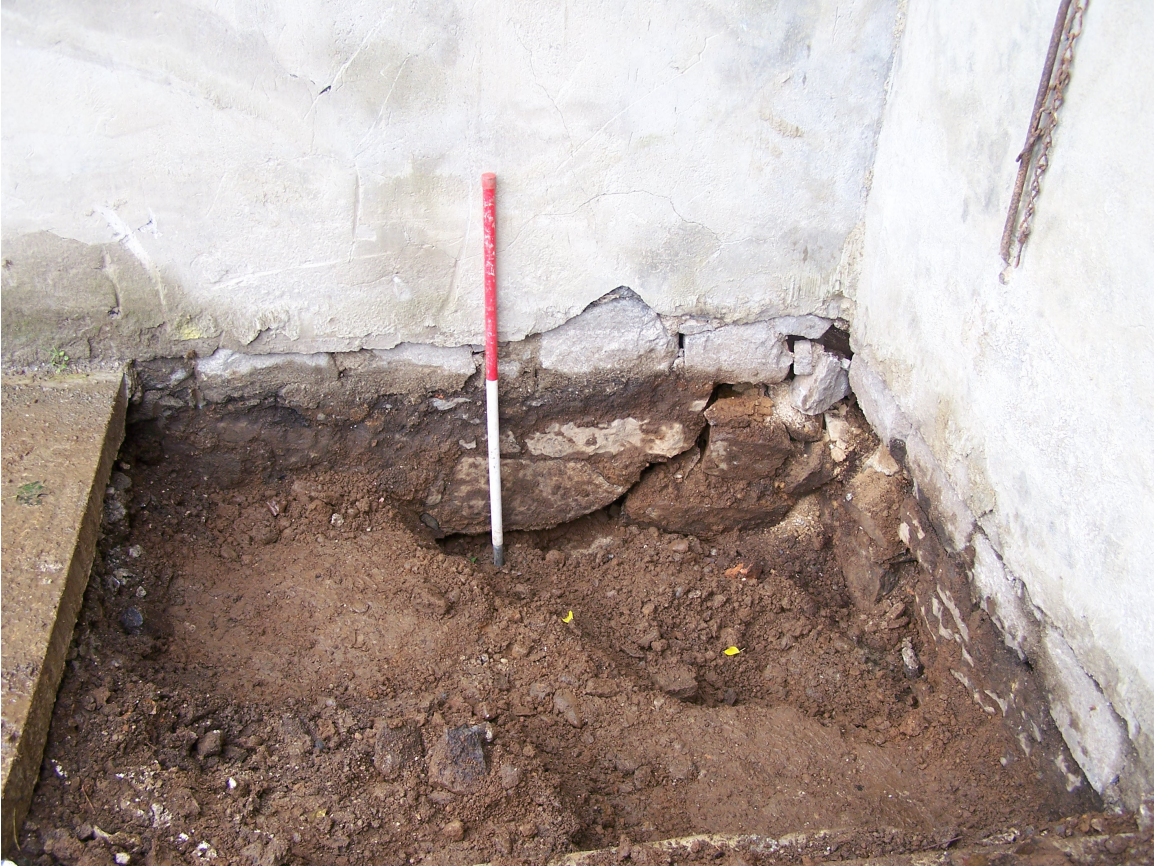
Plate One: Excavation of Test pit 1 in the southwestern corner of Market Yard. Base of the foundations are visible, looking south.

Test Pit	Position in Market Yard	Depth of Foundations
1	South-western	0.3m
2	Southern	0.7m
3	South-eastern	1.4m
4	North-eastern	1.45m

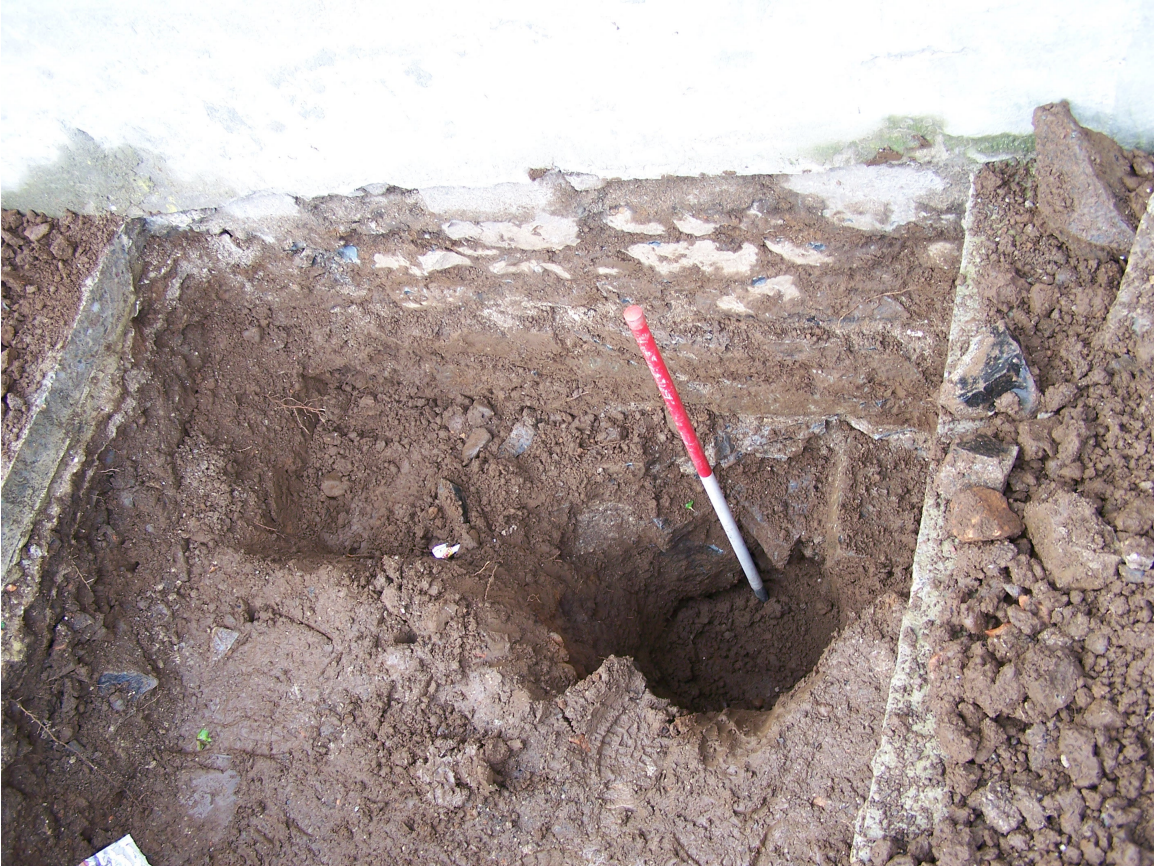
Plate Two: Excavation of Test Pit 2 along the southern wall of the Market Yard. The base of the foundations are visible, looking south.

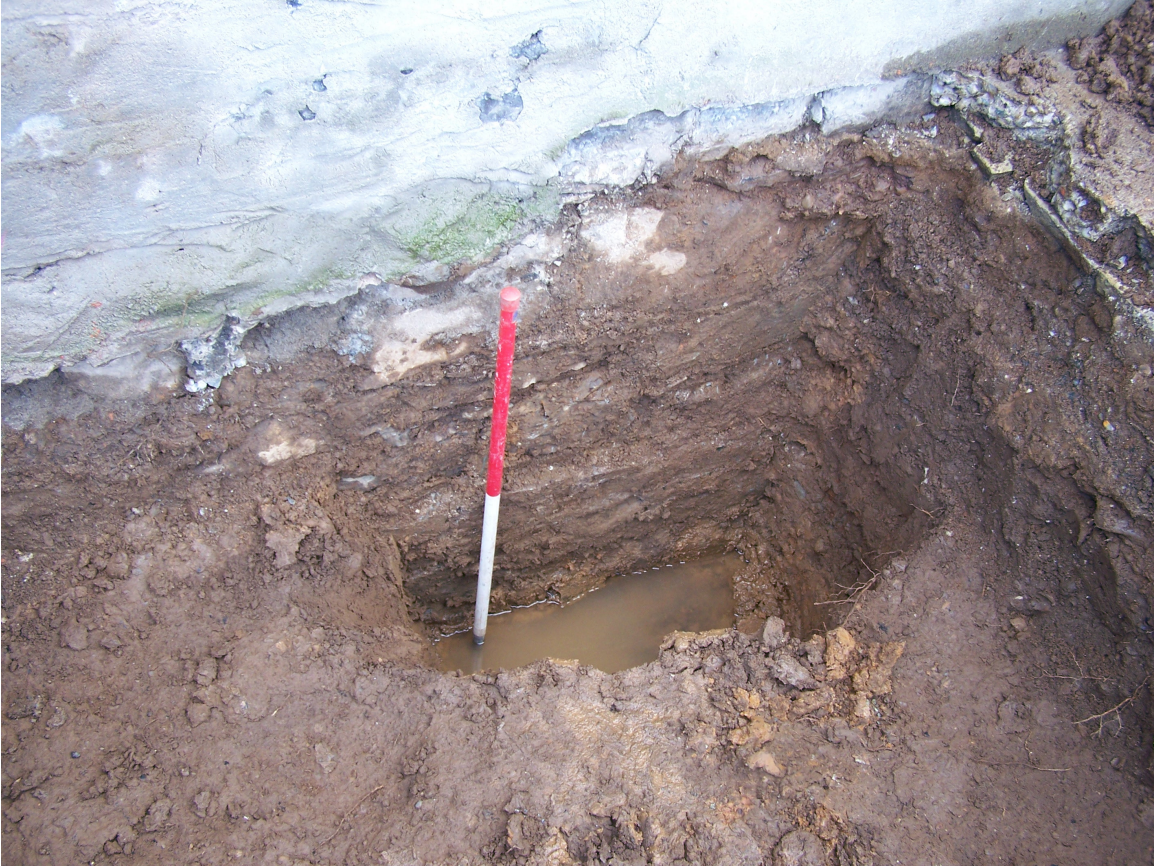
Plate Three: Excavation of Test Pit 3 in the south-eastern area of the Market Yard. The base of the foundations are visible, looking east.

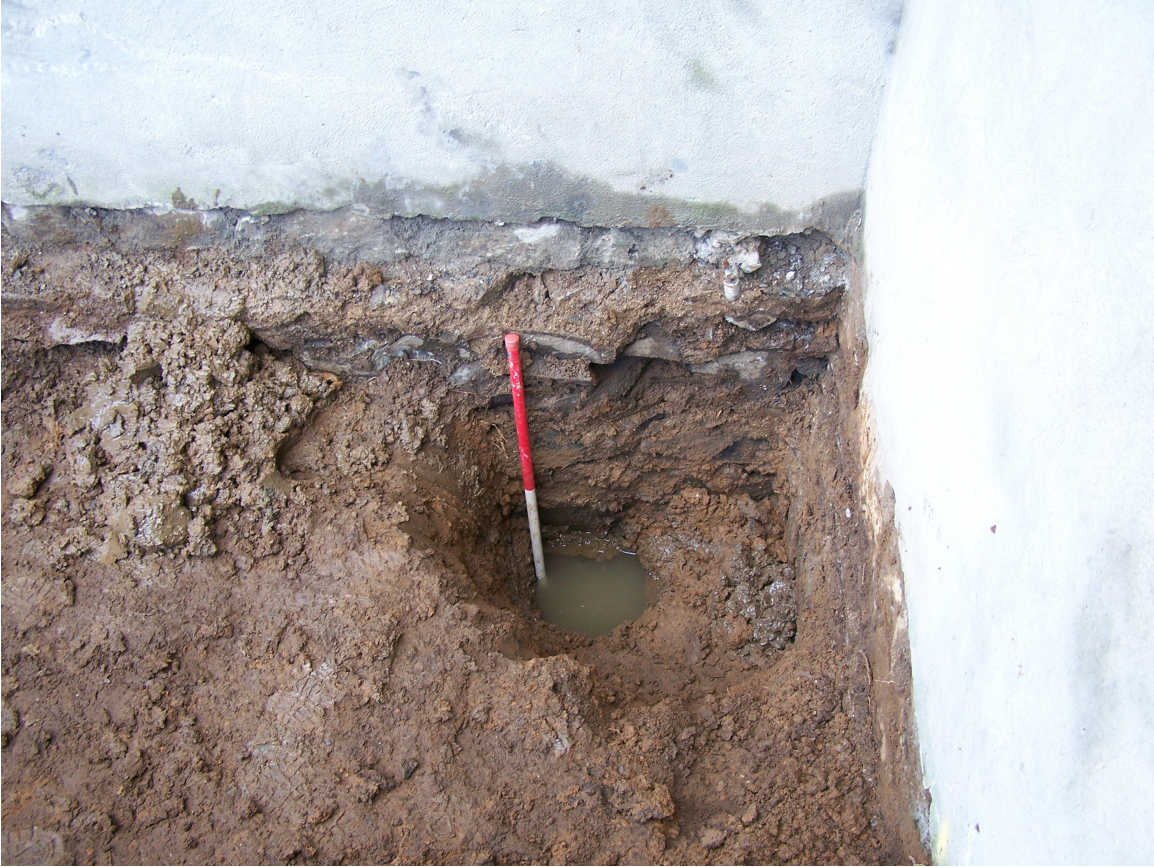
Plate Four: Excavation of Test Pit 4 in the north-eastern corner of the Market Yard. The base of the foundations of the wall can be seen.
