ULSTER ARCHAEOLOGICAL SOCIETY

Survey Report: No. 36

**Survey of Divis Cashel,
County Antrim
UAS/11/05**

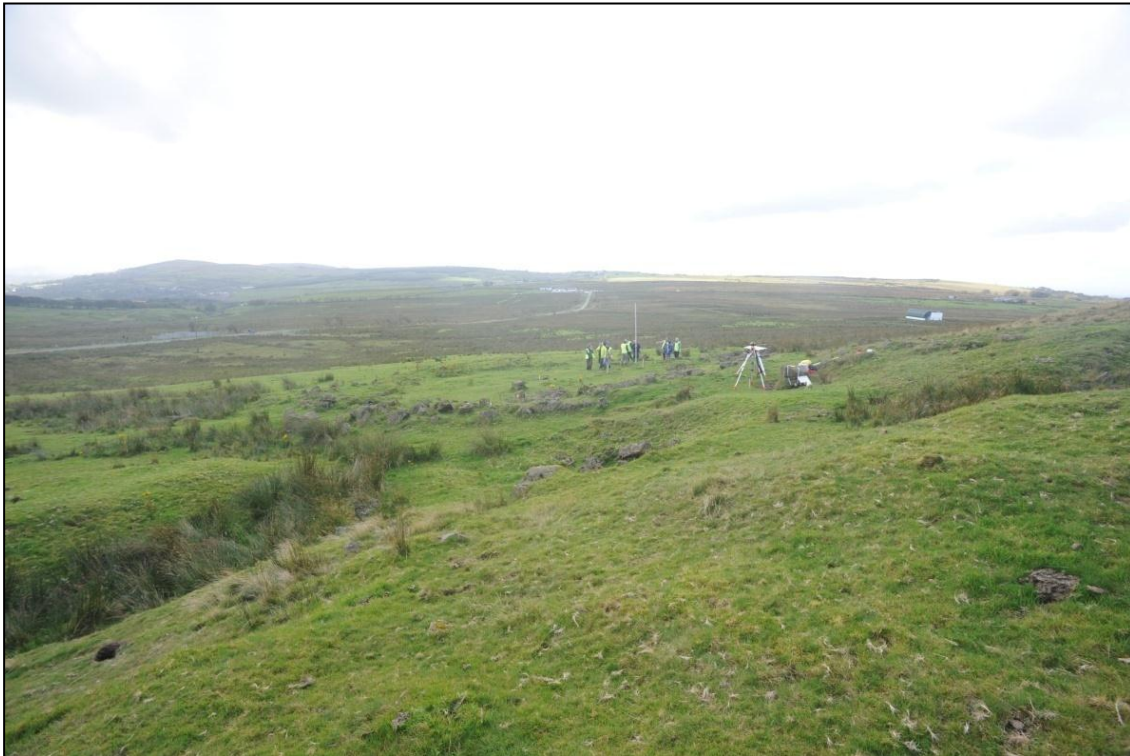
Figure 2: View of the monument looking south-west

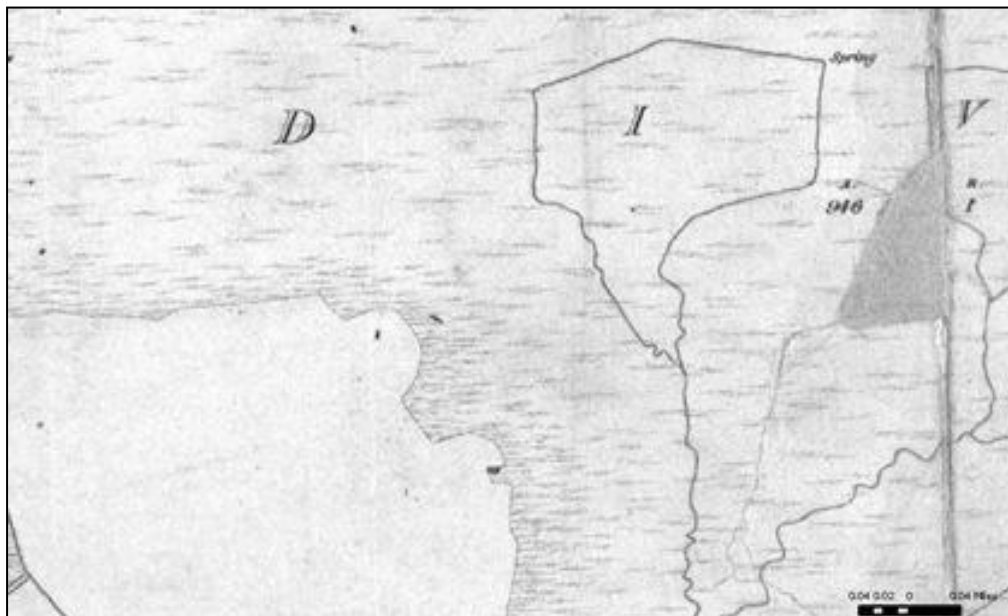
Figure 4: OS County Series Antrim Sheet 5 (part of) 1st edition 1832

The cashel does not appear on the 1832 1st Edition 6 inch County Ordnance Survey map; however it does appear on subsequent editions, where it is referred to as a “Sheepfold”. The associated linear walls which radiate from the structure to the west-north-west and south-east are also recorded in the 2nd Edition 6 inch County Ordnance Survey map and subsequent editions.

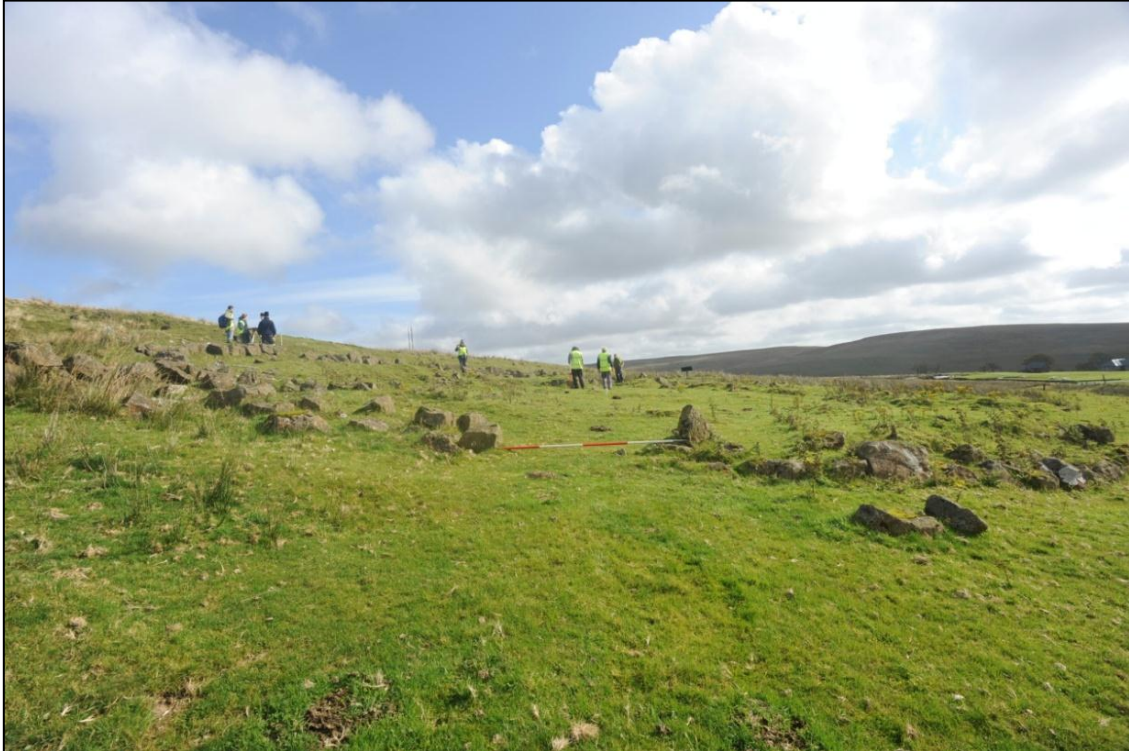
Figure 9: West-north-west entrance of the cashel looking SSE

The enclosure has two possible entrances. The first is to the east side of the wall and has an internal width of 2m. The second is in the west/north-west section of the structure and is also approximately 2m internally; however it is not as well defined as the other entrance and is comprised of smaller set stones.
